DEPARTMENT OF TRANSPORTATION

Contract #: 04-0120F4Cty: SF/ALA Rte: 80 PM: 13.2/13.9File #: 1.28**WELDING INSPECTION REPORT****Resident Engineer:** Casey, William**Address:** 333 Burma Road**City:** Oakland, CA 94607**Report No:** WIR-029466**Date Inspected:** 19-Apr-2013**Project Name:** SAS Superstructure**OSM Arrival Time:** 700**Prime Contractor:** American Bridge/Fluor Enterprises, a JV**OSM Departure Time:** 1730**Contractor:** American Bridge/Fluor Enterprises, a JV**Location:** Job Site**CWI Name:** See below.**CWI Present:** Yes No**Inspected CWI report:** Yes No N/A**Rod Oven in Use:** Yes No N/A**Electrode to specification:** Yes No N/A**Weld Procedures Followed:** Yes No N/A**Qualified Welders:** Yes No N/A**Verified Joint Fit-up:** Yes No N/A**Approved Drawings:** Yes No N/A**Approved WPS:** Yes No N/A**Delayed / Cancelled:** Yes No N/A**Bridge No:** 34-0006**Component:** OBG & Tower**Summary of Items Observed:**

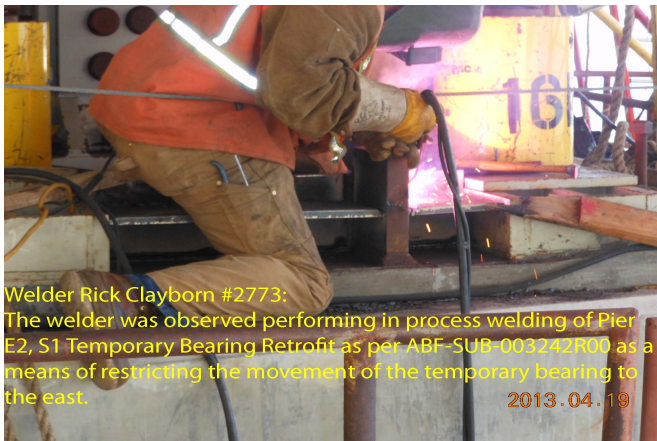
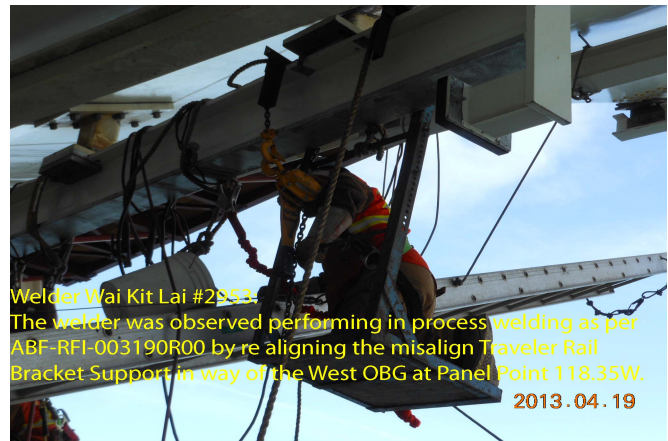
The welder was observed performing in process welding as per ABF-RFI-003190R00 by re aligning the misalign Traveler Rail Bracket Support in way of the West OBG at Panel Point 118.35W. The welder was observed welding utilizing the Welding Procedure Specification (WPS) ABF-WPS-D15-1060A for Shield Metal Arc Welding (SMAW). The welding parameters were verified by QC Inspector Salvador Merino and appeared to be in compliance with the WPS noted above.

The completed and accepted work observed at this location appeared to be in compliance with the contract specifications.
